DAM SAFETY RISK ASSESSMENT FOR KIU KHO MA AND KIU LOM DAMS

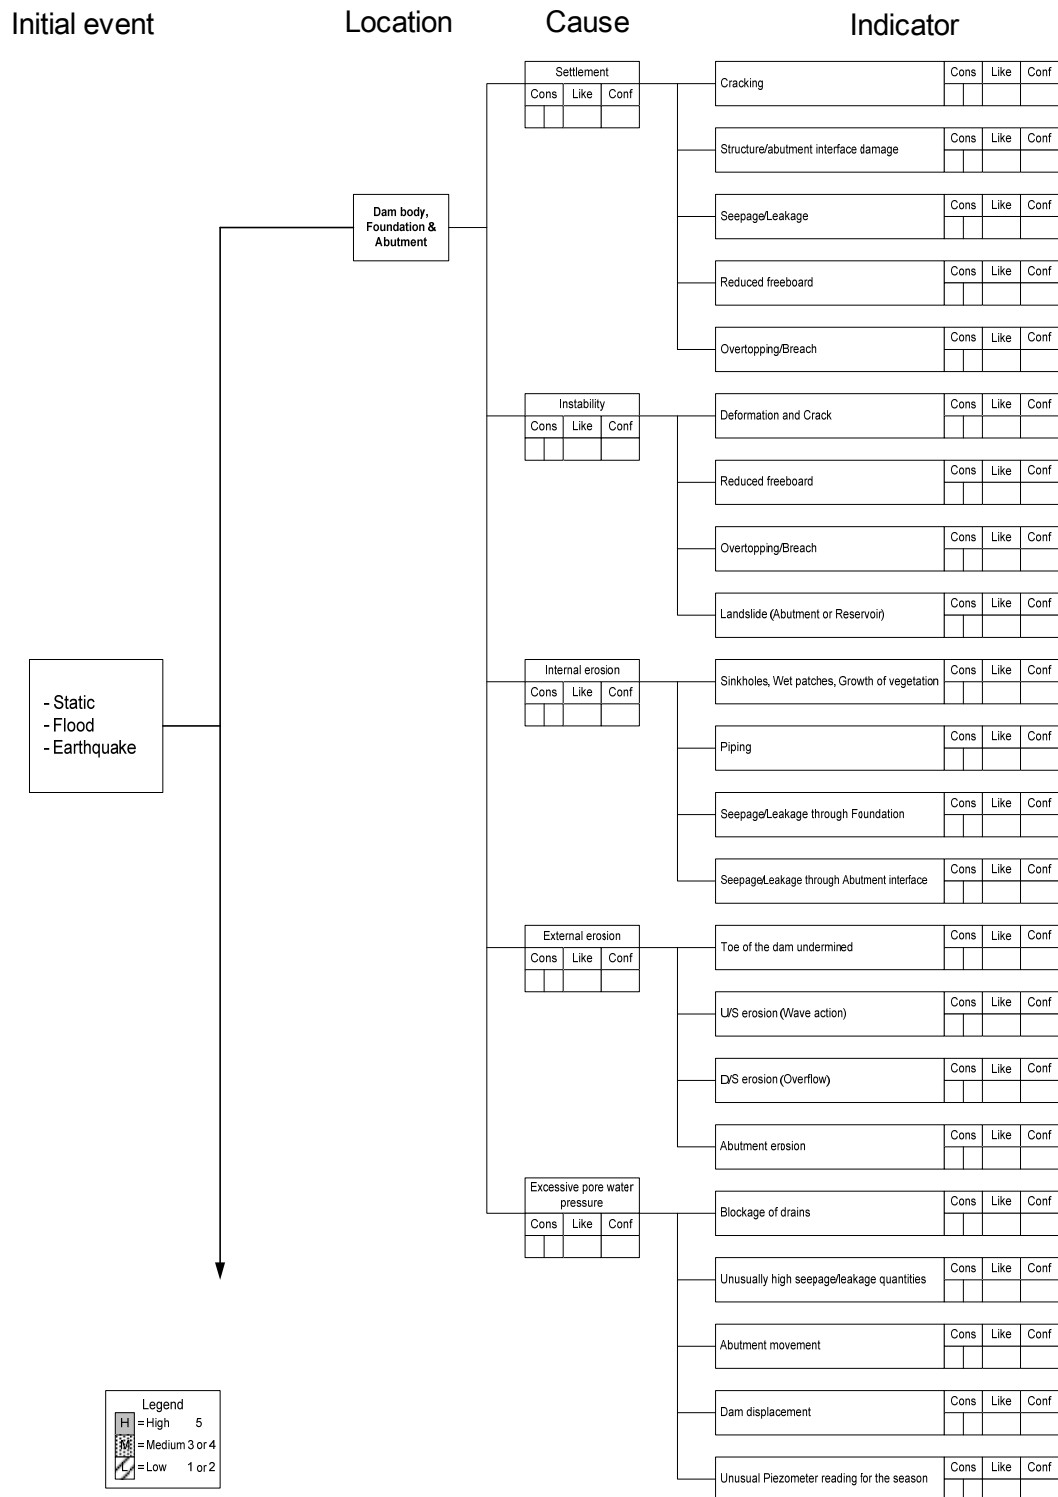
Fig. 2
Part of an LCI diagrams for Kiu Kho Ma dam (main dam)

- 4) Coordination meetings with all relevant parties were held for review and comment on the draft LCI diagram, make any revisions, and finalize the LCI diagram. Fig. 2 and Fig. 3 show some parts of the LCI diagrams of Kiu Kho Ma and Kiu Lom dam, respectively.

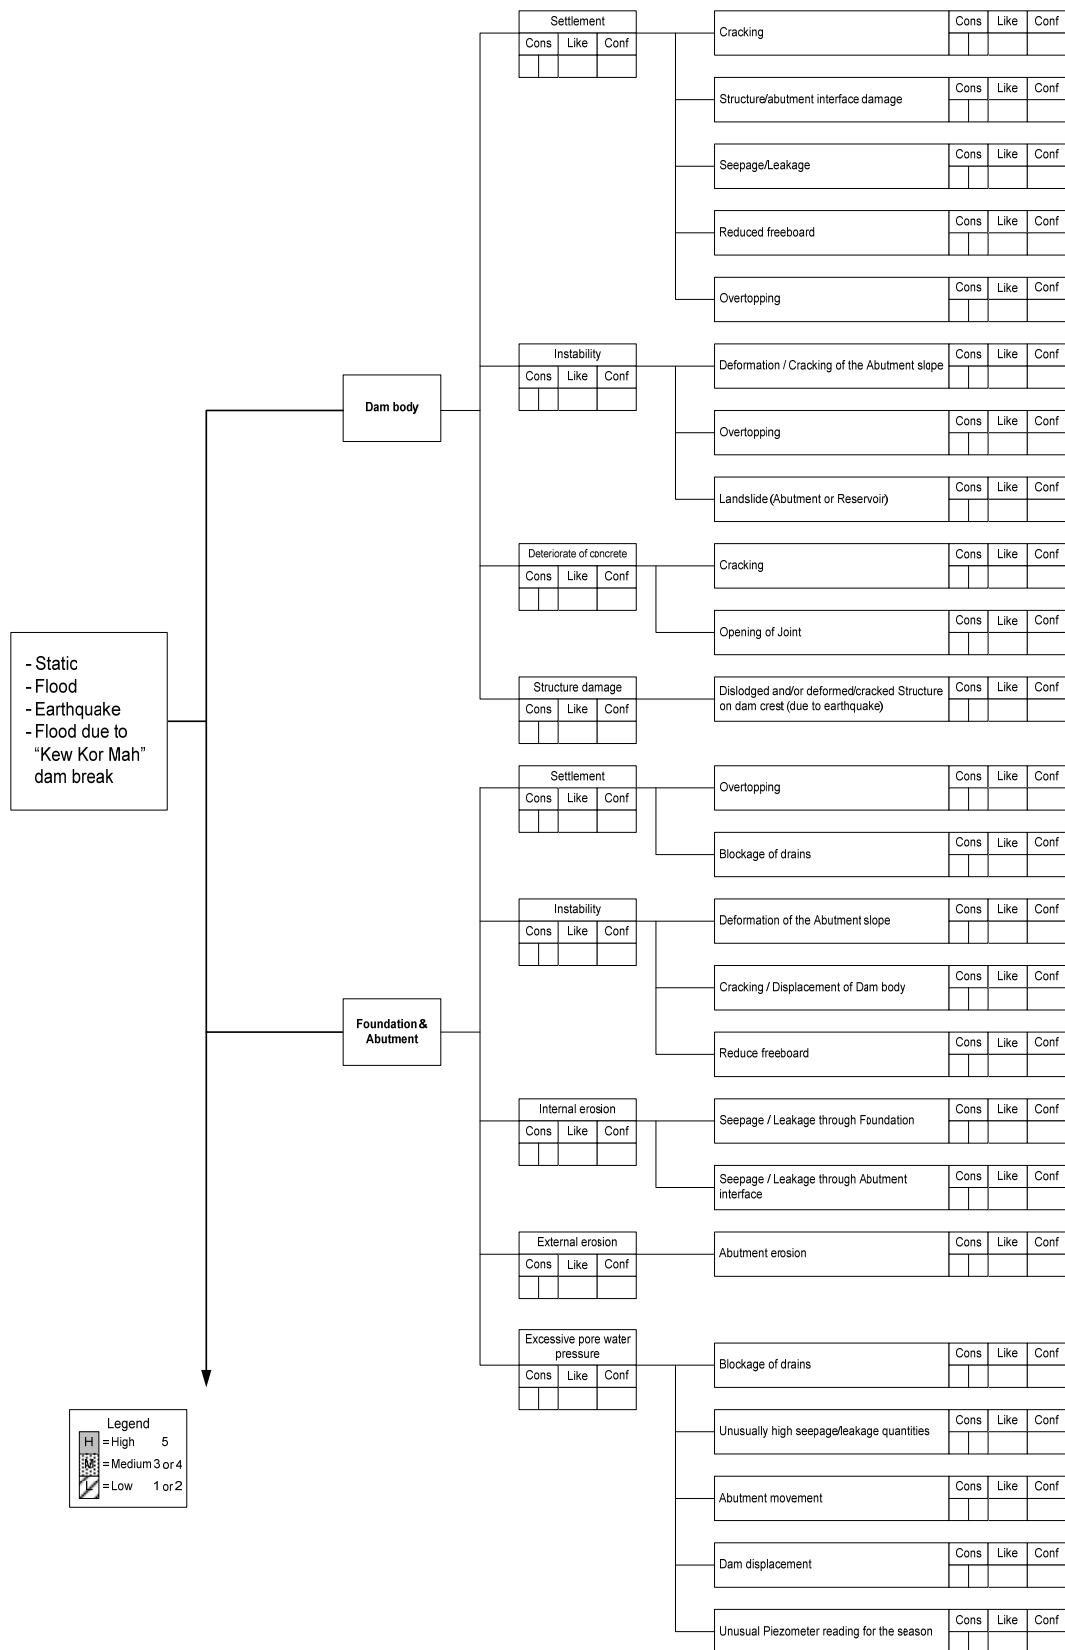
Fig. 3
Part of an LCI diagrams for Kiu Lom dam

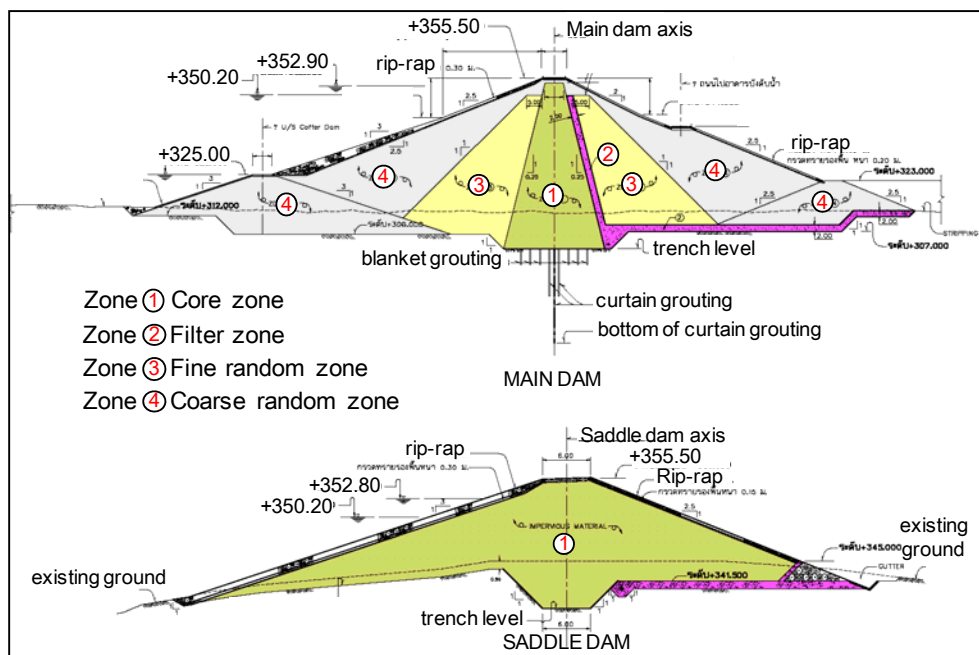
Fig. 4

Representative deepest sections for stability analysis of Kiu Kho Ma dam

Dam's zoning configuration and geometry at the representative deepest section of the main dam and the saddle dam are shown in Fig. 4. The following analysis conditions were analyzed:

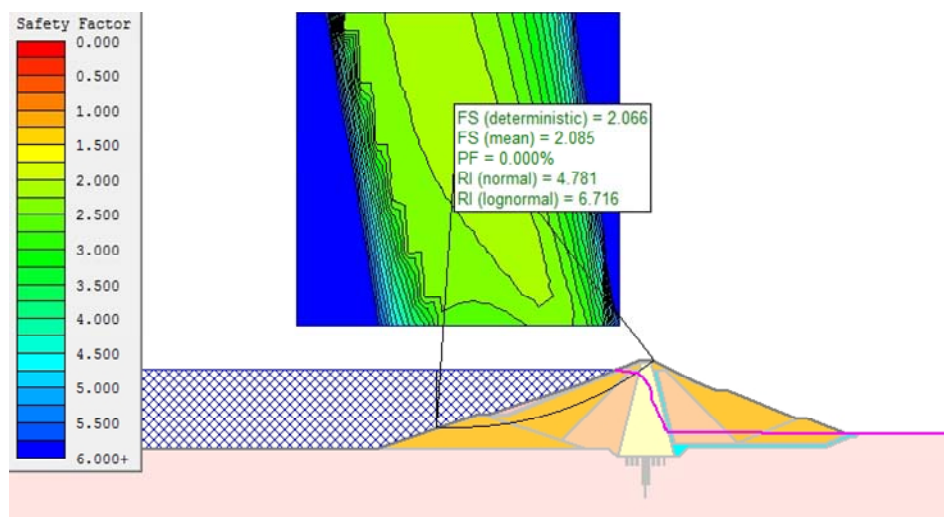
Slope stability analysis result of the main dam (Case 1 Normal operation)

Fig. 5 and Fig. 6 show example of the typical slope stability results for main dam and saddle dam. The slope stability analysis results of upstream and downstream slopes of Kiu Kho Ma dam are summarized in Table 6 and Table 7. It was found that in most case, the slope stability of main dam and saddle dam satisfy the minimum factor of safety requirements against sliding, except for the case of rapid drawdown with earthquake condition (Case 4).

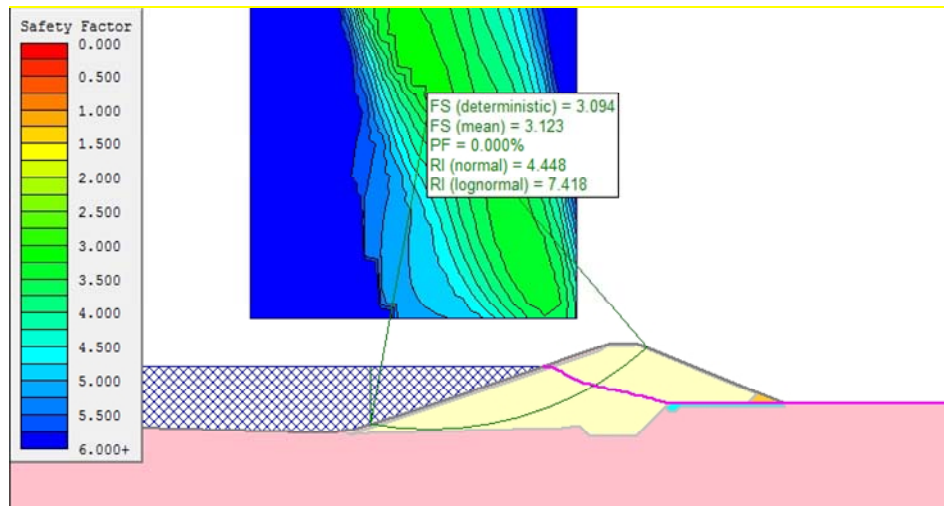
Fig. 6

Slope stability analysis result of the saddle dam (Case 1 Normal operation)

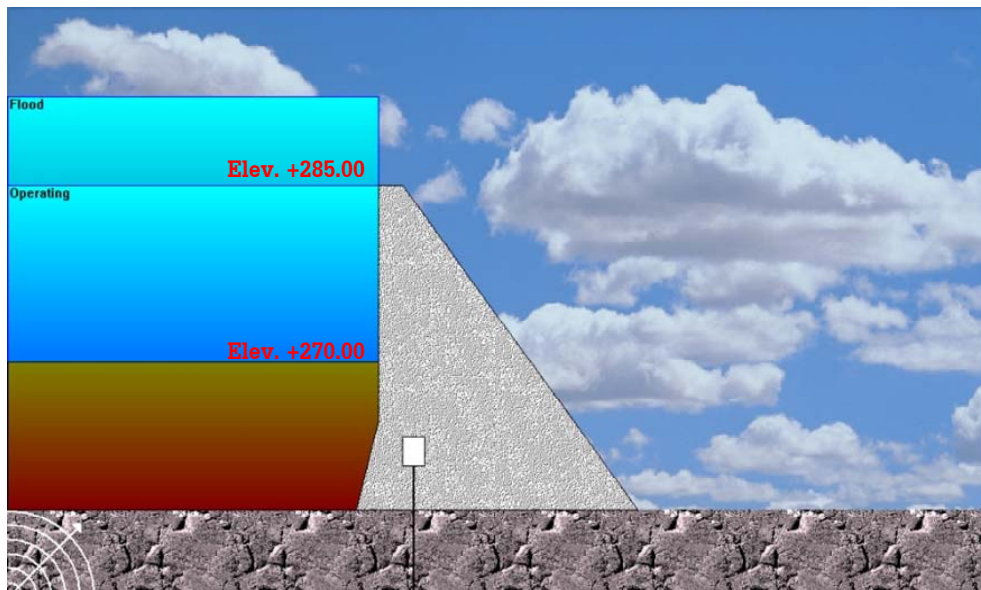
Fig. 7
Kiu Lom dam model in case of all spillway gates are closed

The water level at the upstream face was calculated according to the initial events (normal operation condition, flood condition and cascade failure due to Kiu Koh Ma dam failure) and operation of the spillway (all gates are closed / all gates are opened) as shown in Table 8. Fig. 7 and Fig. 8 show the critical cross sections of Kiu Lom used for the stability analysis.

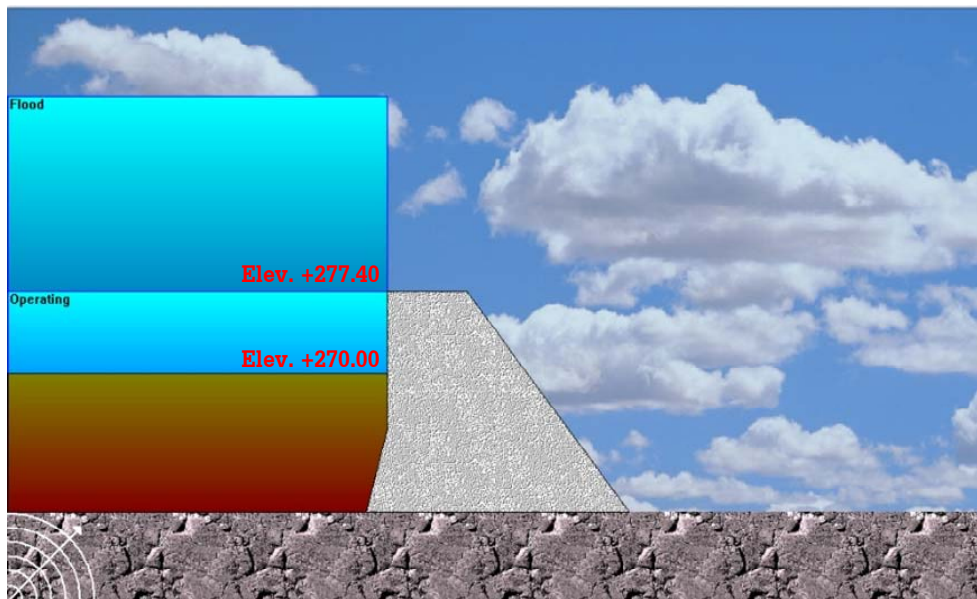
Fig. 8

Kiu Lom dam model in case of all spillway gates are opened
